Inspection Report

Property Address:
11312 StareCt
Baltimore Md 21219

WorkinMan Property Inspections

Date: 3/30/2012	Time: 10:00 AM	Report ID: 33977 Star Lane
Property: 11312 StareCt Baltimore Md 21219	Customer: Danica Sample	Real Estate Professional: Victor Tate Victor Realty

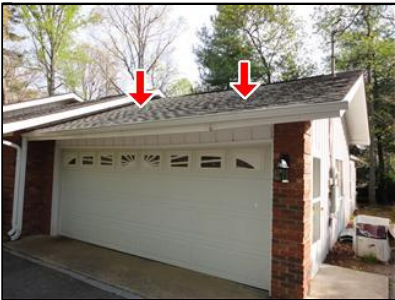
1.0 Picture 1

- 1.0 (1) Evidence of a leak in the Den below corresponds with the middle skylight roof and flashing area. Repairs are needed. Recommend a qualified contractor inspect further and repair as needed.
- 1.0 (2) The roof covering was installed improperly above garage. Roof sheathing needs to be replaced in this area. This will involve some shingle replacement. A qualified contractor should inspect and repair as needed.

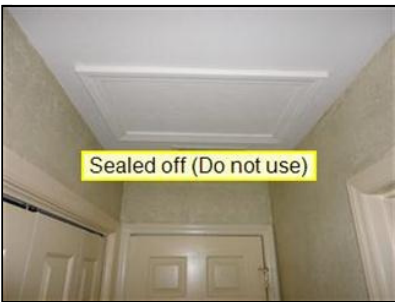
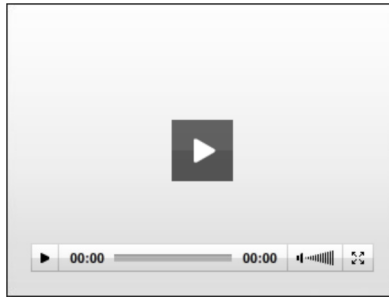
1.5 Picture 1

- 1.5 No longer an attic access. Use the pull down stairs at garage.

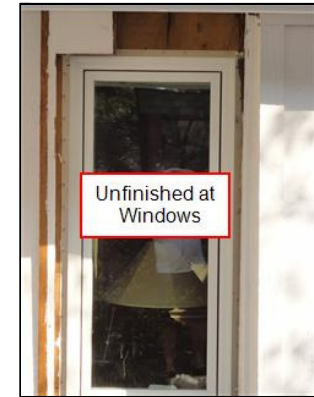
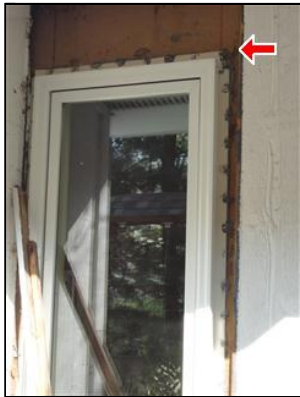
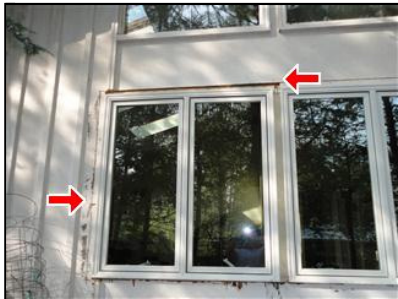
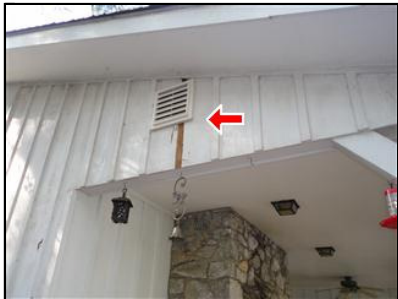
2.0 Picture 1

2.0 The Wood siding at the right side (facing front) and rear of home is missing or incomplete at time of inspection around new premium windows that have recently been installed. I did not inspect the installation of siding at this location. A qualified contractor should inspect and repair as needed.The siding will need prep and paint.

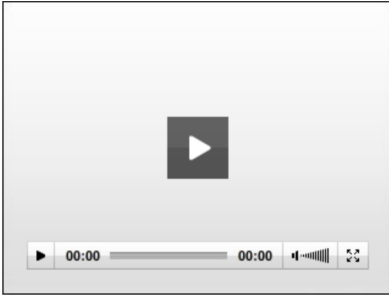
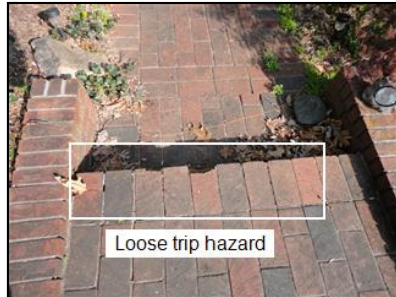
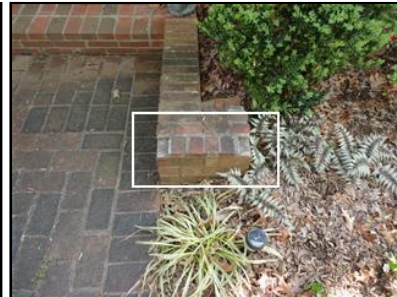
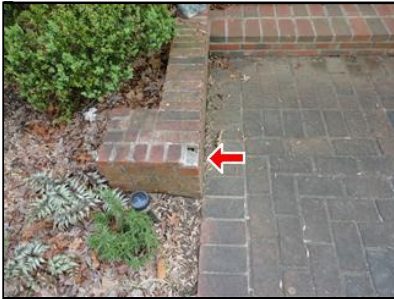
2.4 Picture 2 Water signs at front step

🔊 (2) The brick walkway at the front of home are deteriorated in areas. A general replacement is likely. A qualified contractor should inspect and repair as needed.

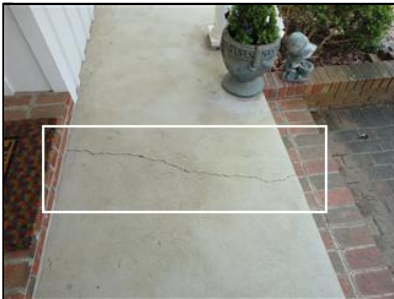
2.4 Picture 6

(3) Concrete is cracked at front entrance of home. Appears to only affect the slab itself and is more cosmetic.

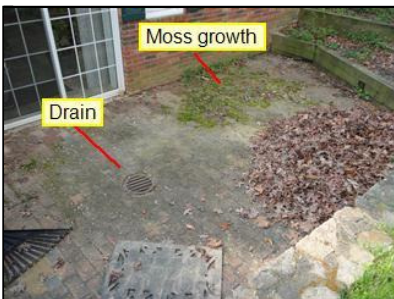
2.4 Picture 7

🔊 (4) The brick floor on the patio at the left side (facing front) has deteriorated mortar or grout, and is loose and uneven in areas. Water can cause further deterioration if not repaired and sealed properly. A qualified contractor should inspect and repair as needed.

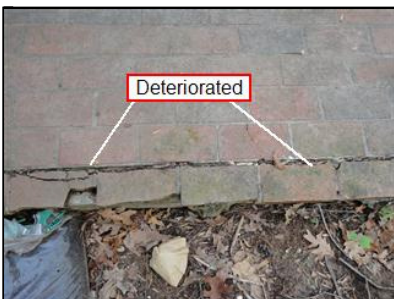
2.4 Picture 8

🔊 (5) The brick floor on the patio at the rear of home is old and deteriorated. A general replacement is likely. A qualified contractor should inspect and repair as needed.

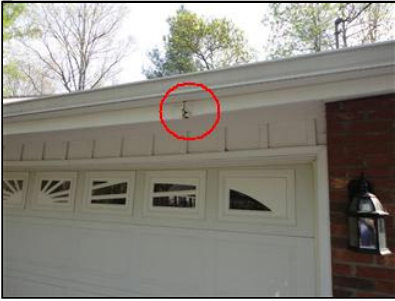
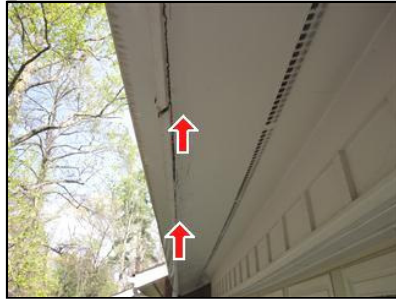
2.5 Picture 1

2.5 (1) The wood fascia and soffit panels at eave on the front of home above garage are deteriorated. Repairs are needed to roof covering as well. A qualified contractor should inspect and repair as needed.

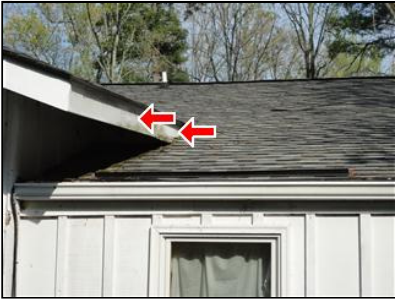
2.5 Picture 3

2.5 (2) The wood fascia at eave on the right side (facing front) is deteriorated. This is a small repair. A qualified contractor should inspect and repair as needed.

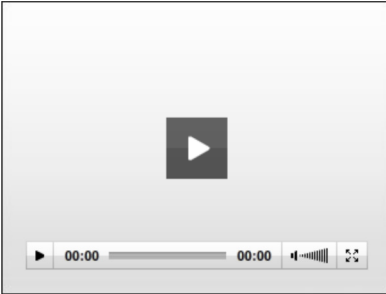
2.8 Picture 1

2.8 Possible bees nest forming at right corner of front steps (see video)

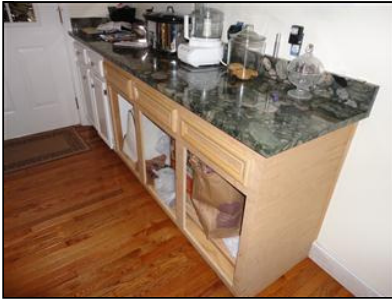
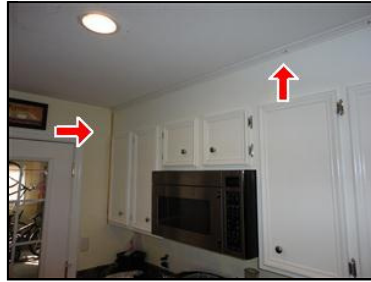
4.5 Picture 1

4.5 Base Cabinetry and trim at wall cabinet are unfinished at kitchen.

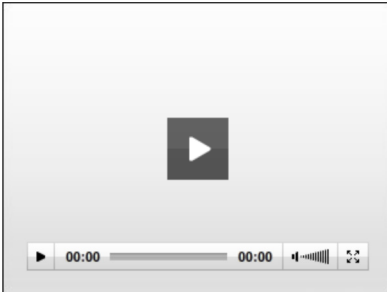
4.9 Picture 1

4.9 The dishwasher is loose and needs securing to underside of countertop (using a proper length screw). I recommend repair as necessary.

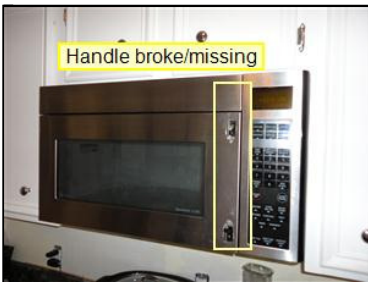
4.14 Picture 1

4.14 The microwave door handle is broken. I recommend repair as needed.

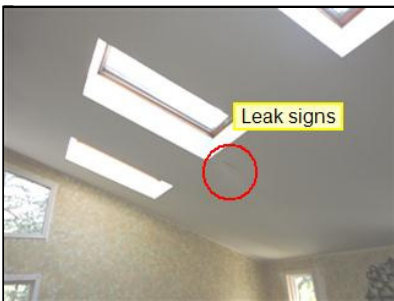
5.0 Picture 1

5.0 (1) The Sheetrock on the ceiling reveals a water stain indicating a leak did or still exists at the Den. Repairs are needed. A qualified contractor should inspect and repair as needed (See Roof Coverings).

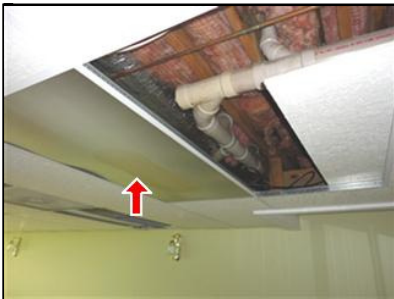
5.0 Picture 2

(2) Water stain on ceiling panel lower level indicates plumbing leak.

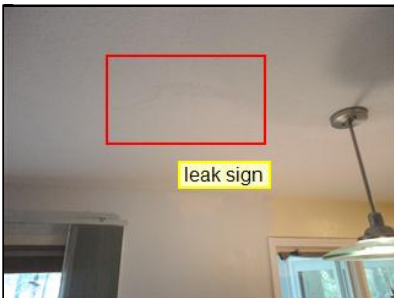
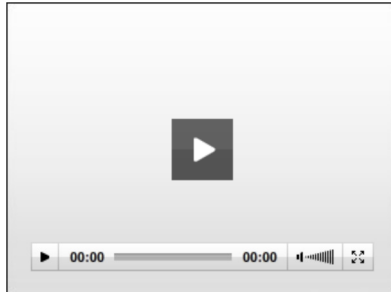
5.0 Picture 3

(3) The Drywall on the ceiling reveals a water stain indicating a leak did or still exists at the Dining Room. Repairs are needed. A qualified contractor should inspect and repair as needed.

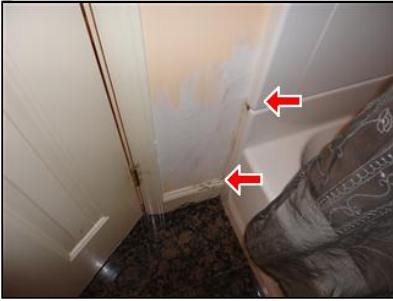
5.1 Picture 1

🔧 (2) The Wall at the bathtub is deteriorated and needs repair or replacement. The wall board and framing may need repair (not visible). I recommend repair or replace using a qualified contractor.

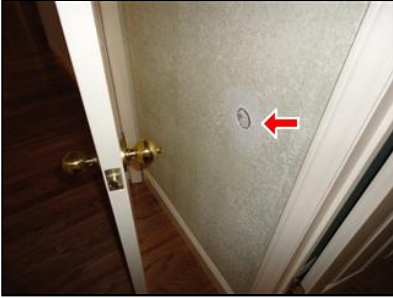
5.1 Picture 2

🔧 (3) The sheetrock on the wall is dented or damaged from door knob at the hallway. While this damage is cosmetic, it needs to be repaired. A qualified contractor should inspect and repair as needed.

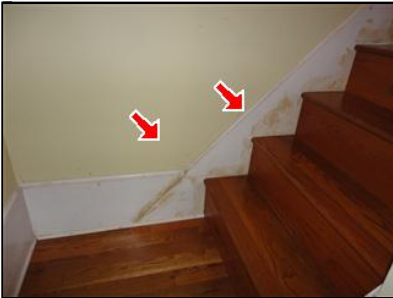
5.1 Picture 3

🔧 (4) Stair cover trim is unfinished needs prep and paint at stairs.

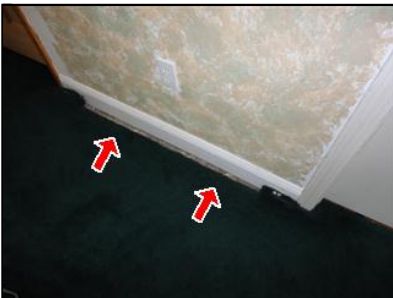
5.2 Picture 1

🔧 **5.2** Carpet is loose or cut short from where electric baseboard use to be in areas around the perimeter of the Den.

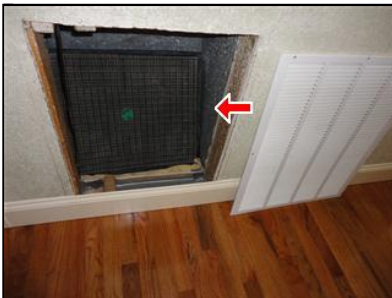
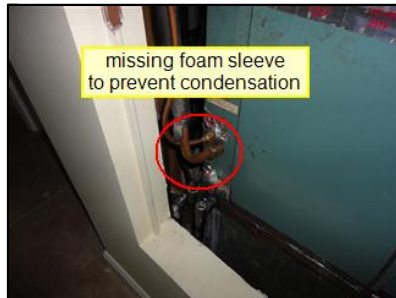
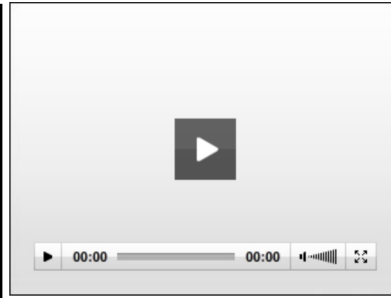
10.3 Picture 1

🔧 **10.3** The washable filter is dirty. The filter needs to be cleaned. Recommend foil taping the filter for a better seal. See Video. Foam sleeve missing at suction line creates condensation and drips water.

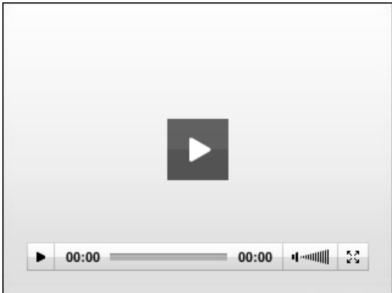
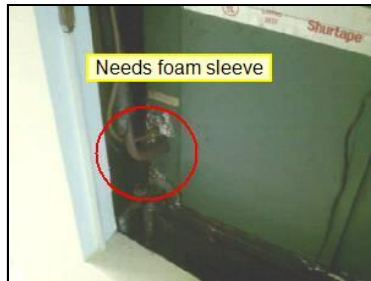
10.8 Picture 1

10.8 Air handler and heat pump is old but appears to be working properly. Foam sleeve on suction line is not covering copper line and condensation can drip.

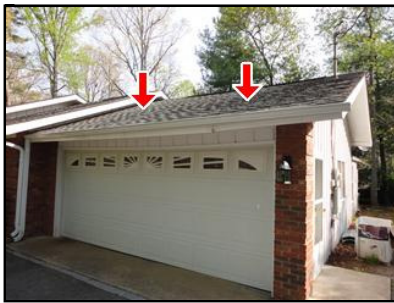
1.0 Picture 1

- ✎ (1) Evidence of a leak in the Den below corresponds with the middle skylight roof and flashing area. Repairs are needed. Recommend a qualified contractor inspect further and repair as needed.
- ✎ (2) The roof covering was installed improperly above garage. Roof sheathing needs to be replaced in this area. This will involve some shingle replacement. A qualified contractor should inspect and repair as needed.

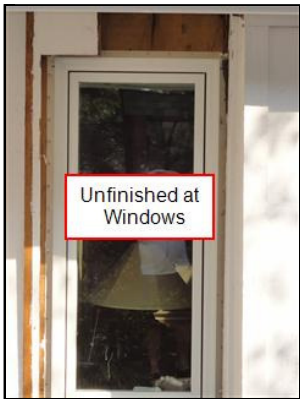
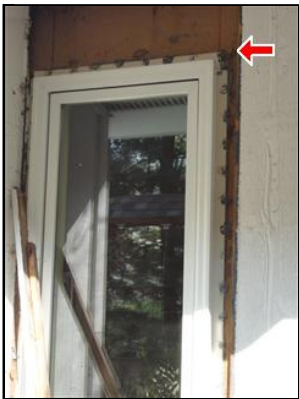
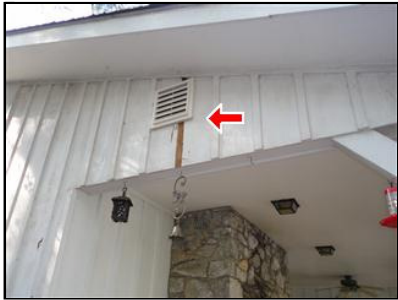
2.0 Picture 1

- ✎ The Wood siding at the right side (facing front) and rear of home is missing or incomplete at time of inspection around new premium windows that have recently been installed. I did not inspect the installation of siding at this location. A qualified contractor should inspect and repair as needed. The siding will need prep and paint.

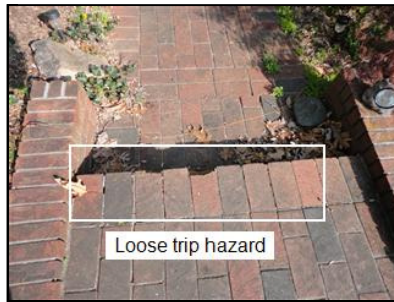
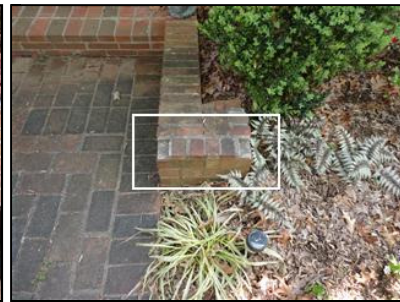
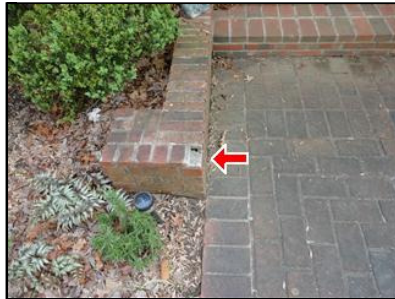
(2) The brick walkway at the front of home are deteriorated in areas. A general replacement is likely. A qualified contractor should inspect and repair as needed.

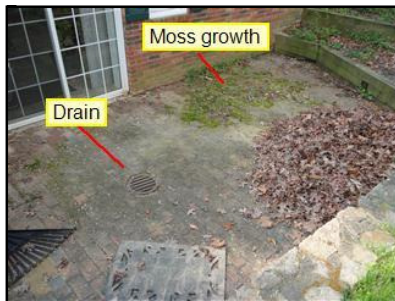
2.4 Picture 7

(4) The brick floor on the patio at the left side (facing front) has deteriorated mortar or grout, and is loose and uneven in areas. Water can cause further deterioration if not repaired and sealed properly. A qualified contractor should inspect and repair as needed.

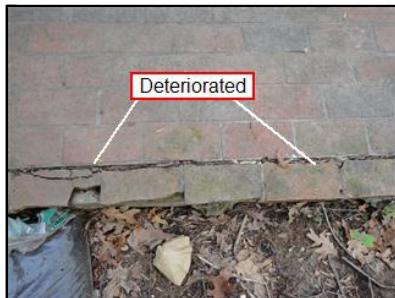
2.4 Picture 8

(5) The brick floor on the patio at the rear of home is old and deteriorated. A general replacement is likely. A qualified contractor should inspect and repair as needed.

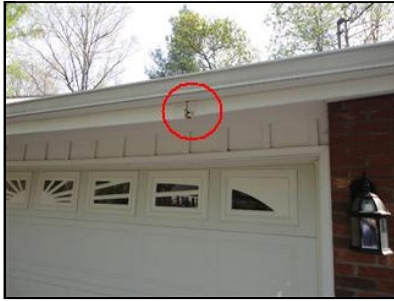
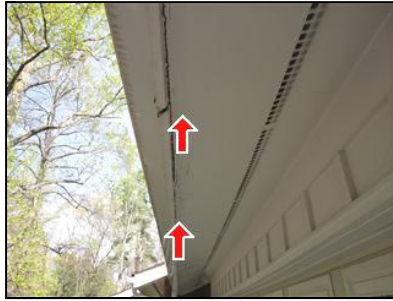
(1) The wood fascia and soffit panels at eave on the front of home above garage are deteriorated. Repairs are needed to roof covering as well. A qualified contractor should inspect and repair as needed.

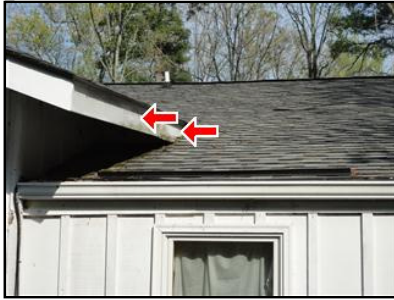
2.5 Picture 3

(2) The wood fascia at eave on the right side (facing front) is deteriorated. This is a small repair. A qualified contractor should inspect and repair as needed.

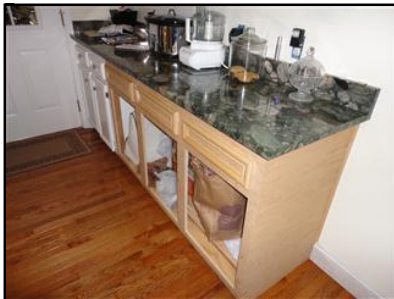
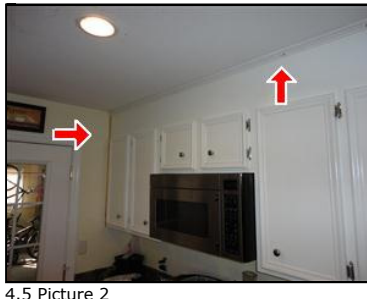
Base Cabinetry and trim at wall cabinet are unfinished at kitchen.

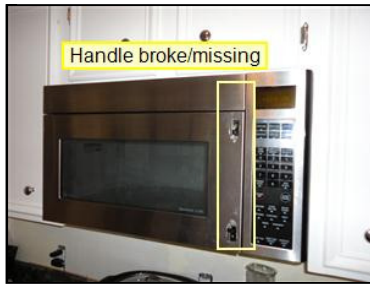
4.14 Picture 1

The microwave door handle is broken. I recommend repair as needed.

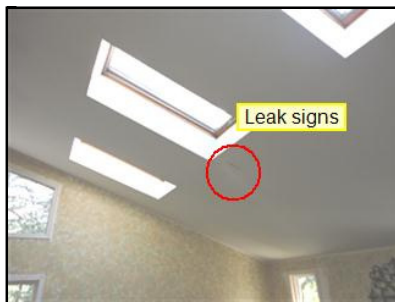
5.0 Picture 1

(1) The Sheetrock on the ceiling reveals a water stain indicating a leak did or still exists at the Den. Repairs are needed. A qualified contractor should inspect and repair as needed (See Roof Coverings).

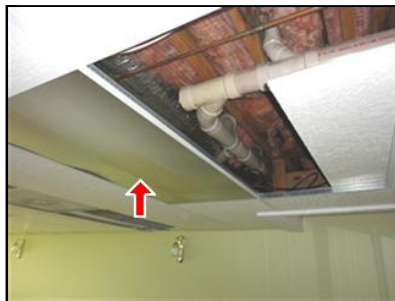
5.0 Picture 2

(2) Water stain on ceiling panel lower level indicates plumbing leak.

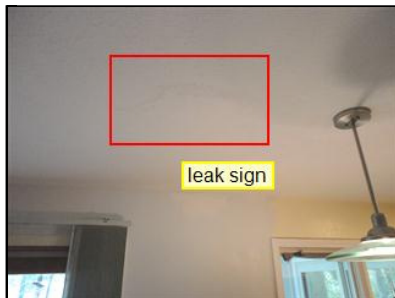
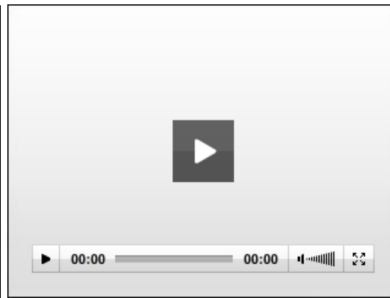
(3) The Drywall on the ceiling reveals a water stain indicating a leak did or still exists at the Dining Room. Repairs are needed. A qualified contractor should inspect and repair as needed.

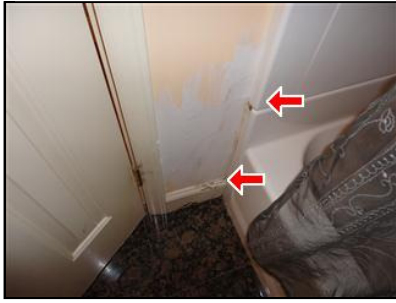
5.1 Picture 1

(2) The Wall at the bathtub is deteriorated and needs repair or replacement. The wall board and framing may need repair (not visible). I recommend repair or replace using a qualified contractor.

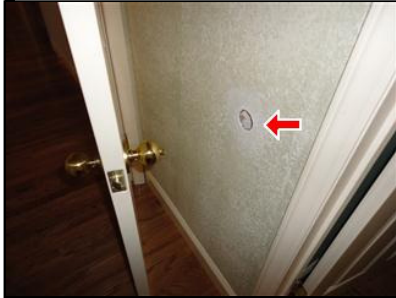
5.1 Picture 2

(3) The sheetrock on the wall is dented or damaged from door knob at the hallway. While this damage is cosmetic, it needs to be repaired. A qualified contractor should inspect and repair as needed.

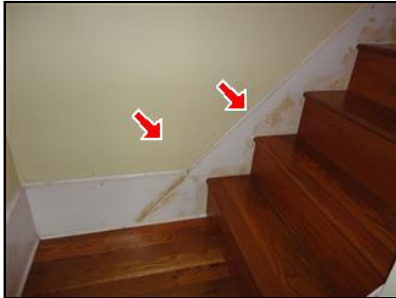
5.1 Picture 3

(4) Stair cover trim is unfinished needs prep and paint at stairs.

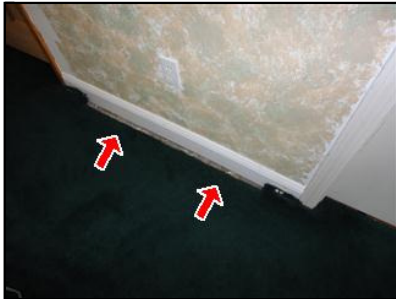
5.2 Picture 1

Carpet is loose or cut short from where electric baseboard use to be in areas around the perimeter of the Den.

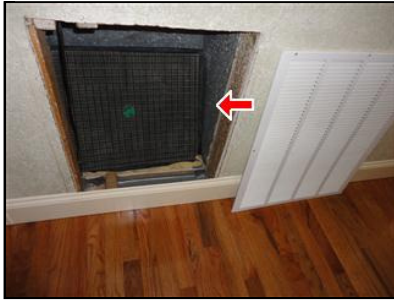
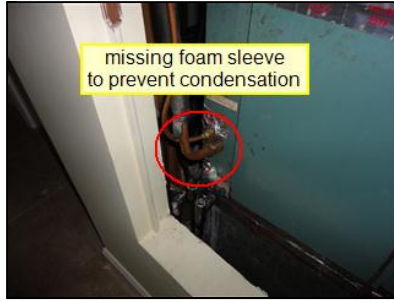
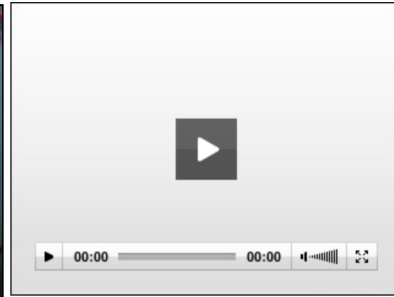
The washable filter is dirty. The filter needs to be cleaned. Recommend foil taping the filter for a better seal. See Video. Foam sleeve missing at suction line creates condensation and drips water.
